Docket No. SA-537

Attachment 7 – Test Plan and Results of Tensile Testing

777 Pack Release Mechanism Strength Test Plan

777 Pack Release Tensile Report 11-7-2013

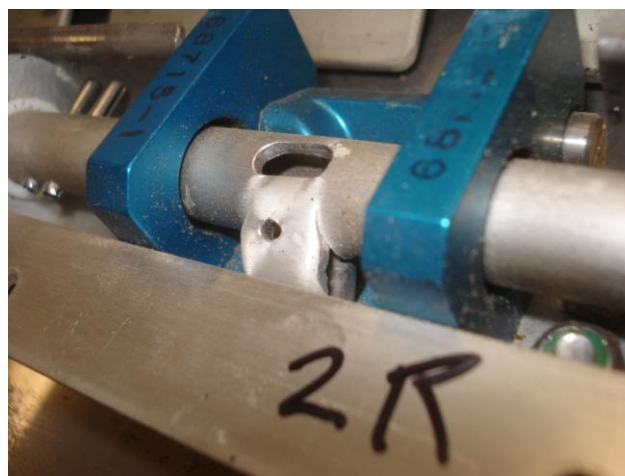
Figure 1. Damage to Release Shaft Door 2 RH.

The investigation revealed a failure mode of the pack release mechanism. The release shafts showed signs of damage in the interface area of the tang. Minor cases showed bulging of the aluminum shaft while more severe cases showed a fracture of the aluminum and significant displacement of the tang. See Figure 1.

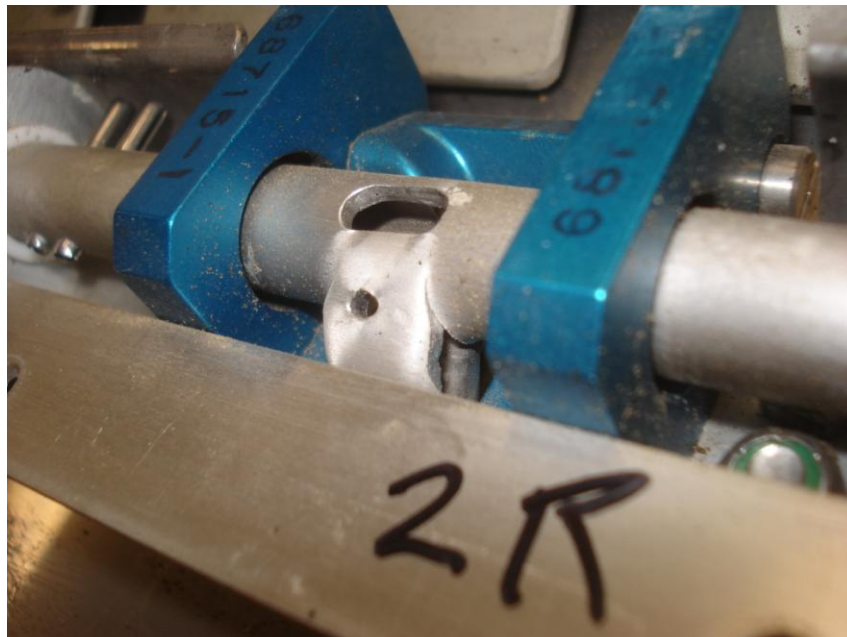
Figure 1. Damage to Release Shaft Door 2 RH.

The investigation revealed a failure mode of the pack release mechanism. The release shafts showed signs of damage in the interface area of the tang. Minor cases showed bulging of the aluminum shaft while more severe cases showed a fracture of the aluminum and significant displacement of the tang. See Figure 1.

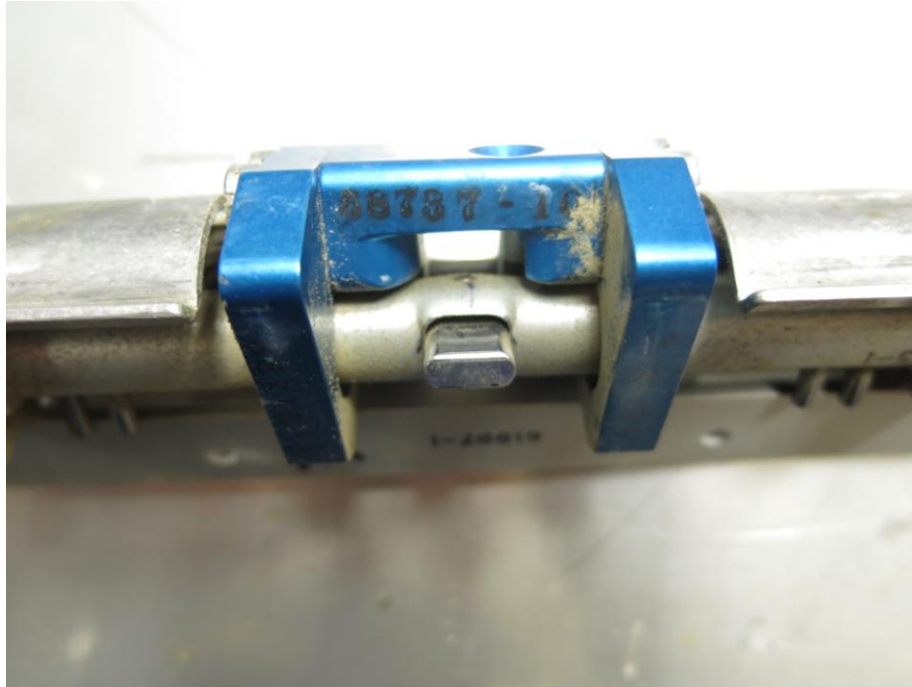
Figure 2. Damage to Release Shaft Door 1 RH

The purpose of the testing detailed in this report is to understand the level of force that needs to be applied to the release mechanism to cause the lower lacing cover to release from the mechanism. An additional goal is to replicate the same type of damage seen on the escape slides from the Asiana Flight 214 aircraft, as shown in Figures 1 & 2.

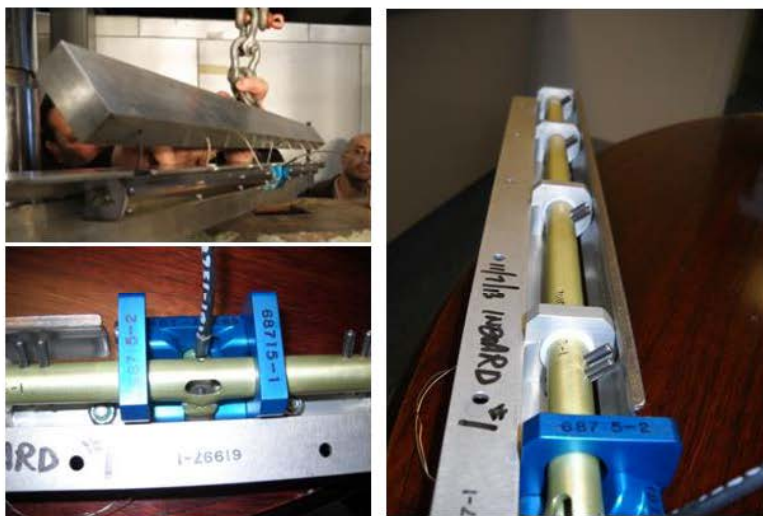
Post-test Photos

- Frame rate of 600 fps for video was too high, resulting in dark, out of focus images. Team agreed to reduce to 300 fps for the remaining tests.
- Damage seen in the tang area is consistent with that seen on some of the release mechanisms recovered from Asiana Flight 214.
- Shaft rotated approximately 90°
- 5 cables pulled out nearly simultaneously but the test was ended before any other cables could pull out.

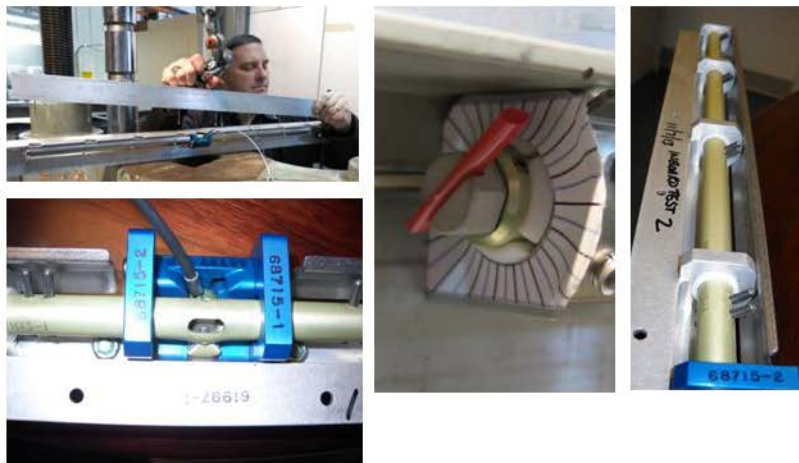
Post-test Photos

- Damage seen in the tang area is consistent with that seen on some of the release mechanisms recovered from Asiana Flight 214.
- Red plastic piece was added to the slot on the end of the release shaft as a visual indicator for the rotation.
- Shaft rotated approximately 90°
- Five cables pulled out nearly simultaneously. Two others pulled out as the test continued.

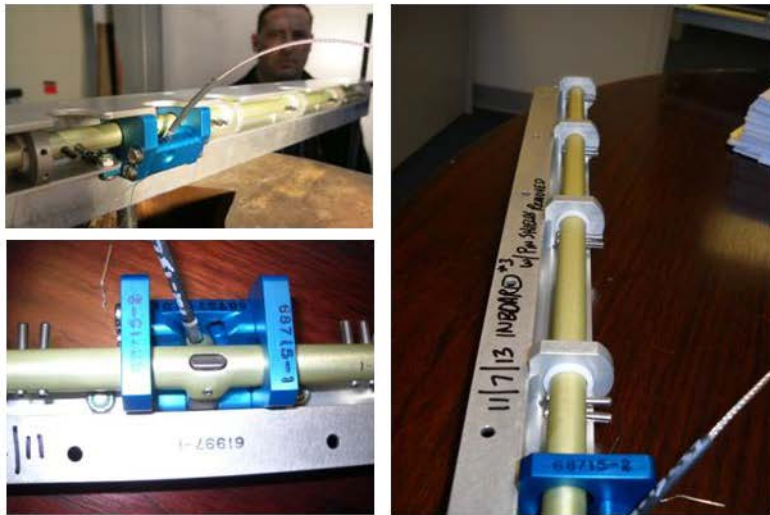
Post-test Photos

- Damage seen in the tang area is consistent with that seen on some of the release mechanisms recovered from Asiana Flight 214, though the damage is less than that seen on the previous tests that included the pin shields.
- The release shaft did not rotate as far compared to the previous tests that included the pin shields.
- All cables appeared to release simultaneously.

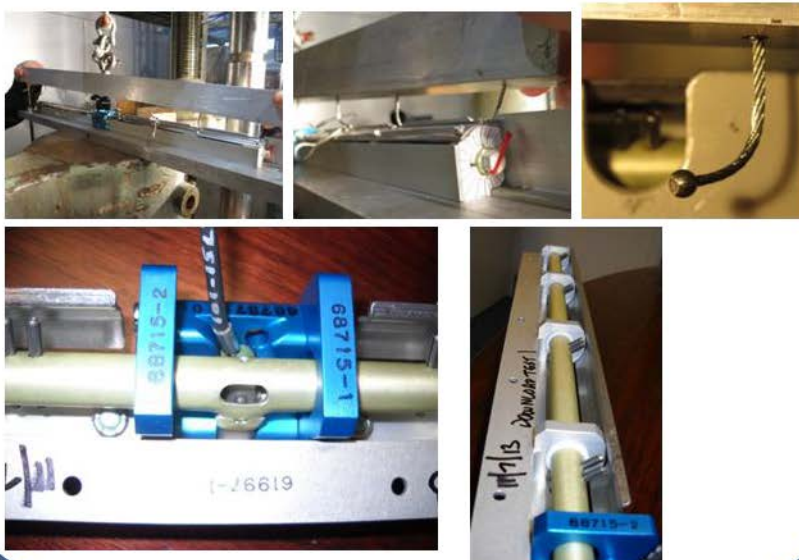
Post-test Photos

- Damage seen in the tang area is consistent with that seen on some of the release mechanisms recovered from Asiana Flight 214.
- The shaft rotated approximately 90°.
- The cables after the test had a distinct curl to them, which was not observed during the inboard tests.
- 5 cables pulled out simultaneously. Two others pulled out as the test continued.

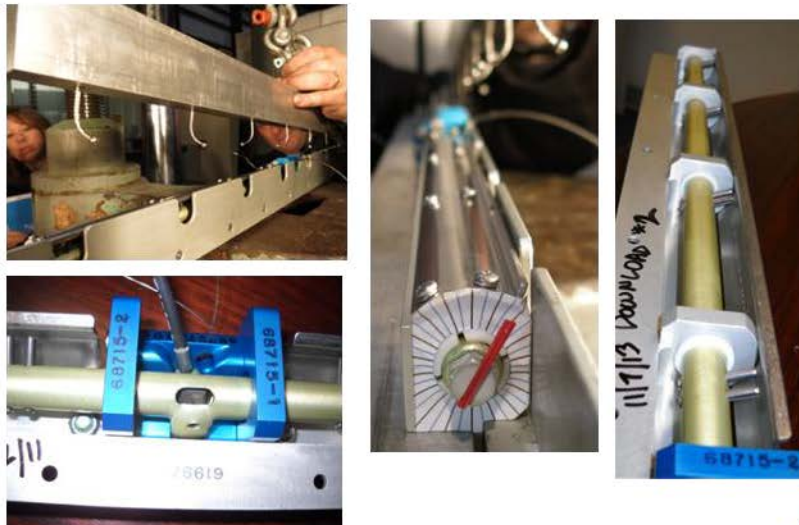
Post-test Photos

- Damage seen in the tang area is consistent with that seen on some of the release mechanisms recovered from Asiana Flight 214.
- The shaft rotated slightly less than 90°.
- Four cables release simultaneously. Three others released as the test continued.
- The release cables exhibited a curled appearance.

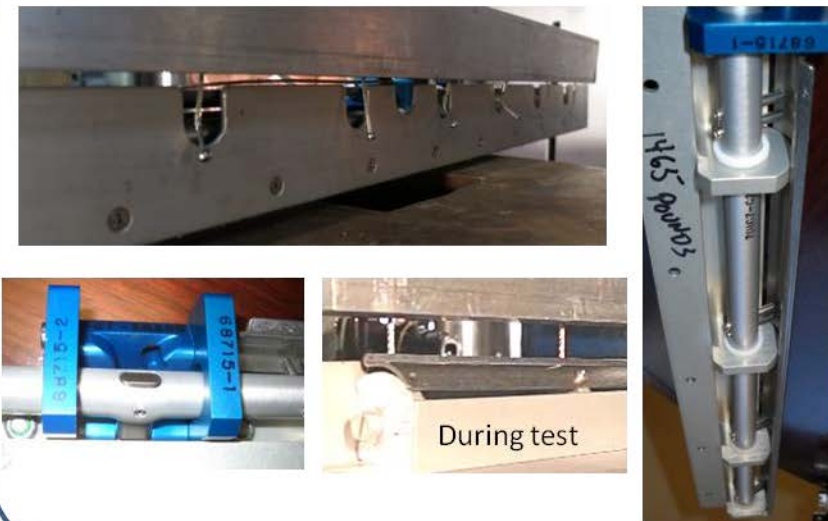
Post-test Photos

- Damage seen in the tang area is consistent with that seen on the DR 1RH release mechanism recovered from Asiana Flight 214.
- The shaft rotated much less than 90°.
- This test resulted in the lowest force measured to release the cables.
- The video shows the pin shields flexing, which creates space for the balls to pull through.
